# New York State Department of Transportation

## Yellow Flag NB22CTW008

**BIN: 1065318**

Location: Span 165, Girder G19 at Pier 165

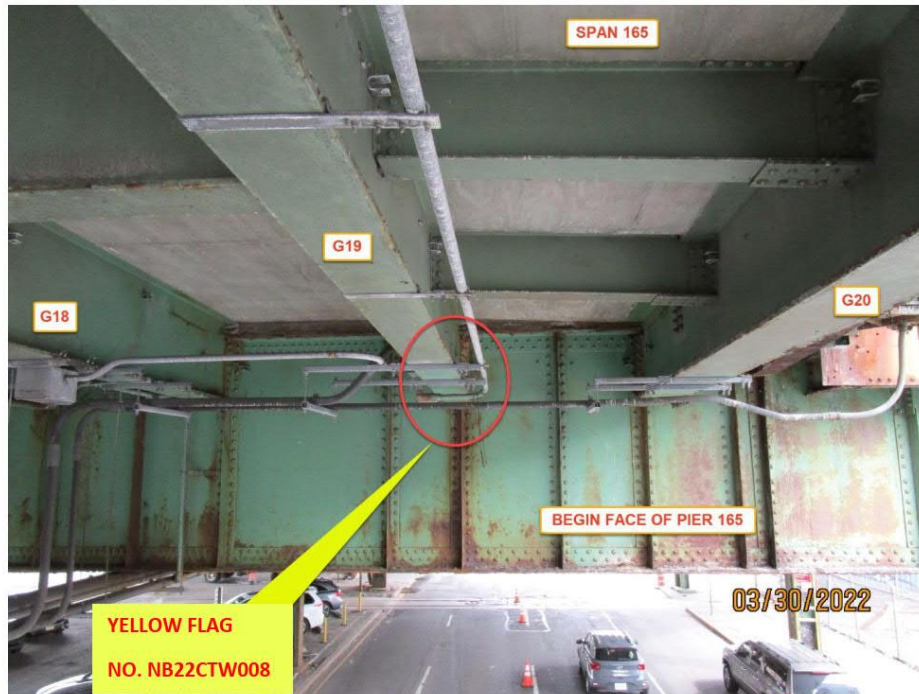
Photo Number: 1

**Attachment Description:** General view of the flagged condition at Girder G 19 in Span 165 at Pier 165. Looking End.

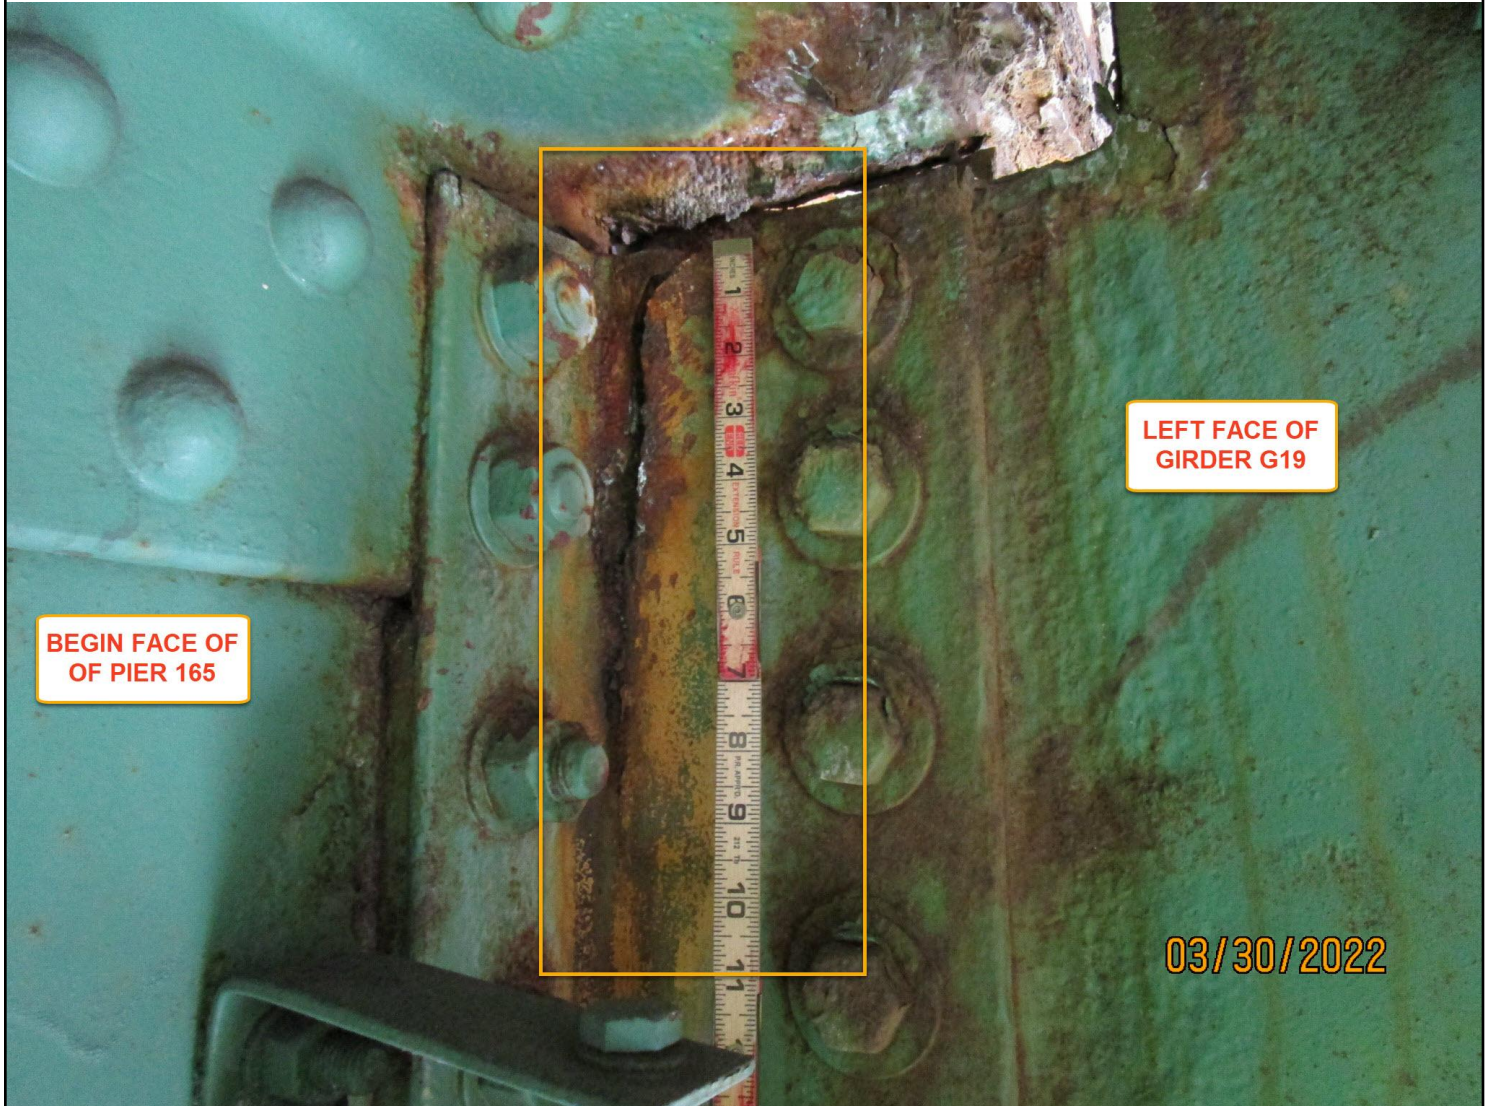
Photo Number: 2

Description: The connection angles at both faces of Girder G19 in Span 165 at Pier 165 exhibit cracks along the fillets of the angles. The left connection angle exhibits a 9" long vertical crack (no change in condition) along the fillet starting at the top of the angle (Photo 2). The right connection angle exhibits a 7-1/2" long diagonal crack (no change in condition) stemming from the 4"L x 1"H corrosion hole at the top of the angle and continuing into the fillet (Photo 3). The end of Girder G19 is framed into the pier web with the connection angles.

**Attachment Description:** The left face of Girder G19 in Span 165 at Pier 165. The connection angle exhibits a vertical crack at the top of the angle along the fillet. Looking Right.

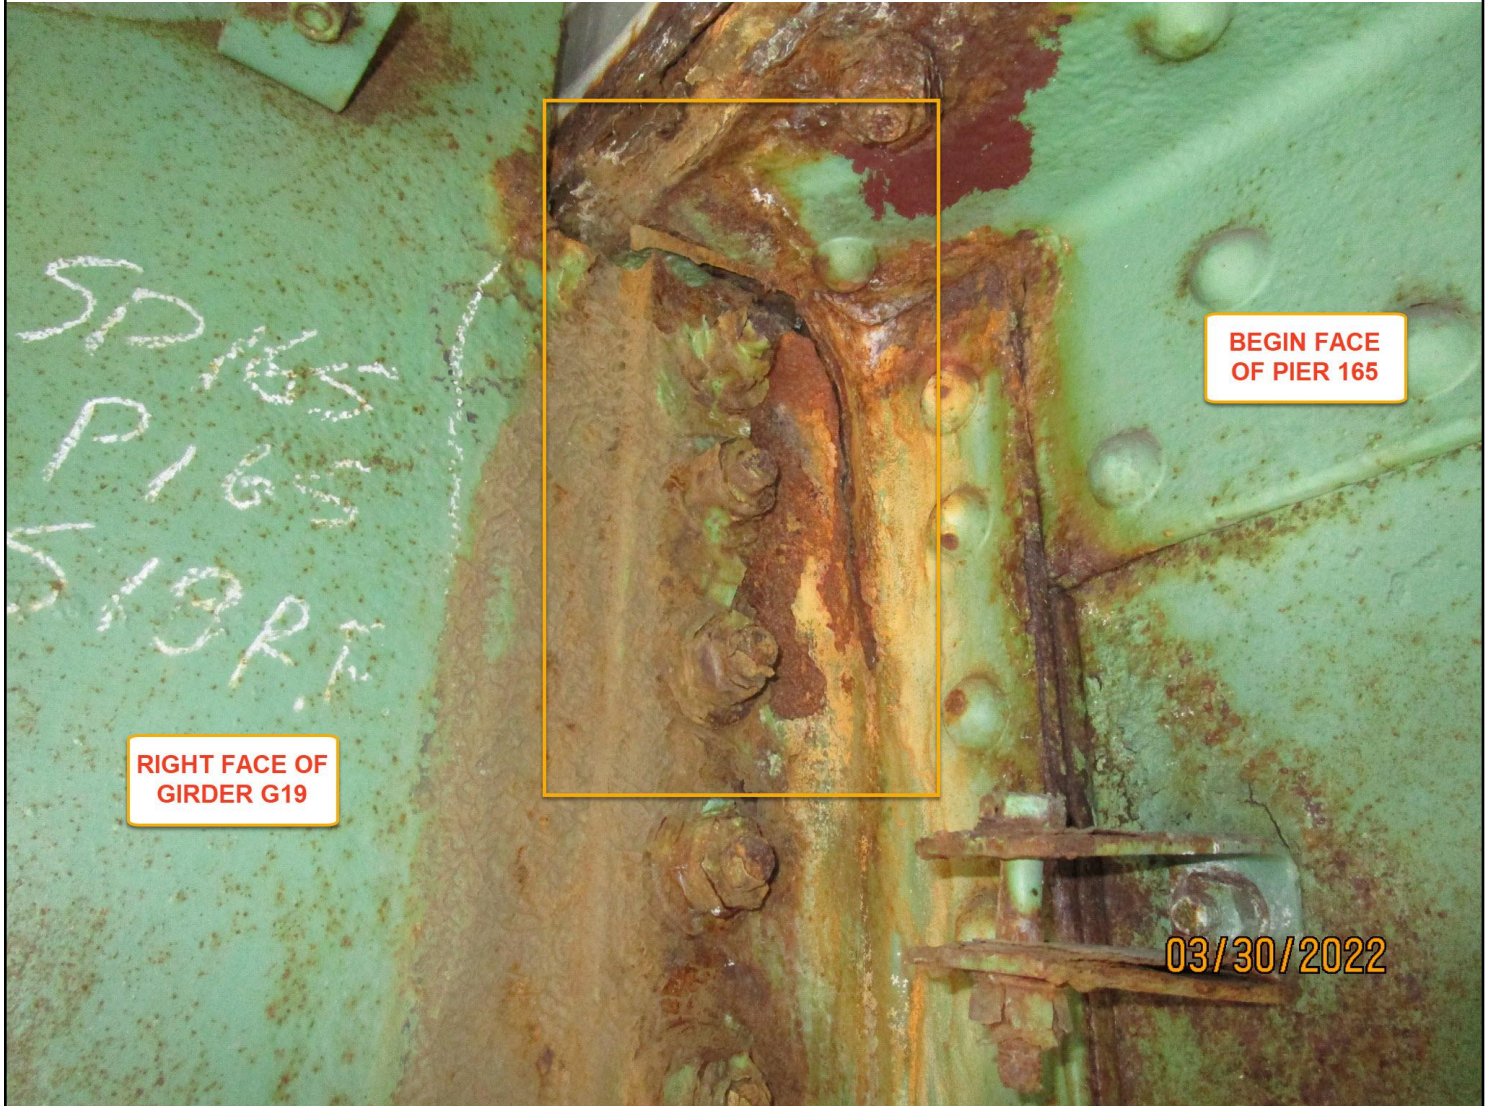
Photo Number: 3

**Attachment Description:** The right face of Girder G19 in Span 165 at Pier 165: The connection angle exhibits a diagonal crack stemming from the corrosion hole at the top of the angle and continuing into the fillet. Looking Left.

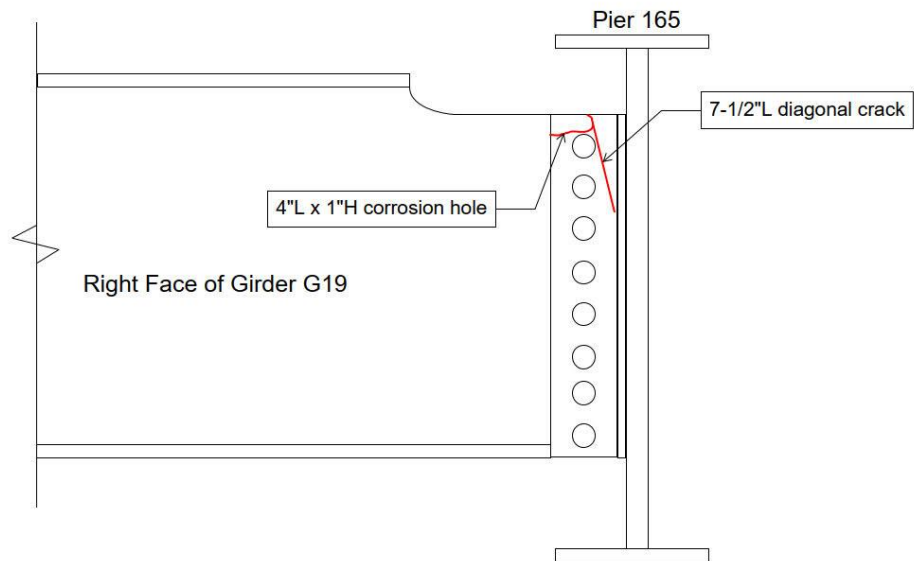
**Right Face of Girder G19 in Span 165 at Pier 165**  
**N.T.S.**

***Attachment Description: SN 165 G19 at Pier 165 Sketch***

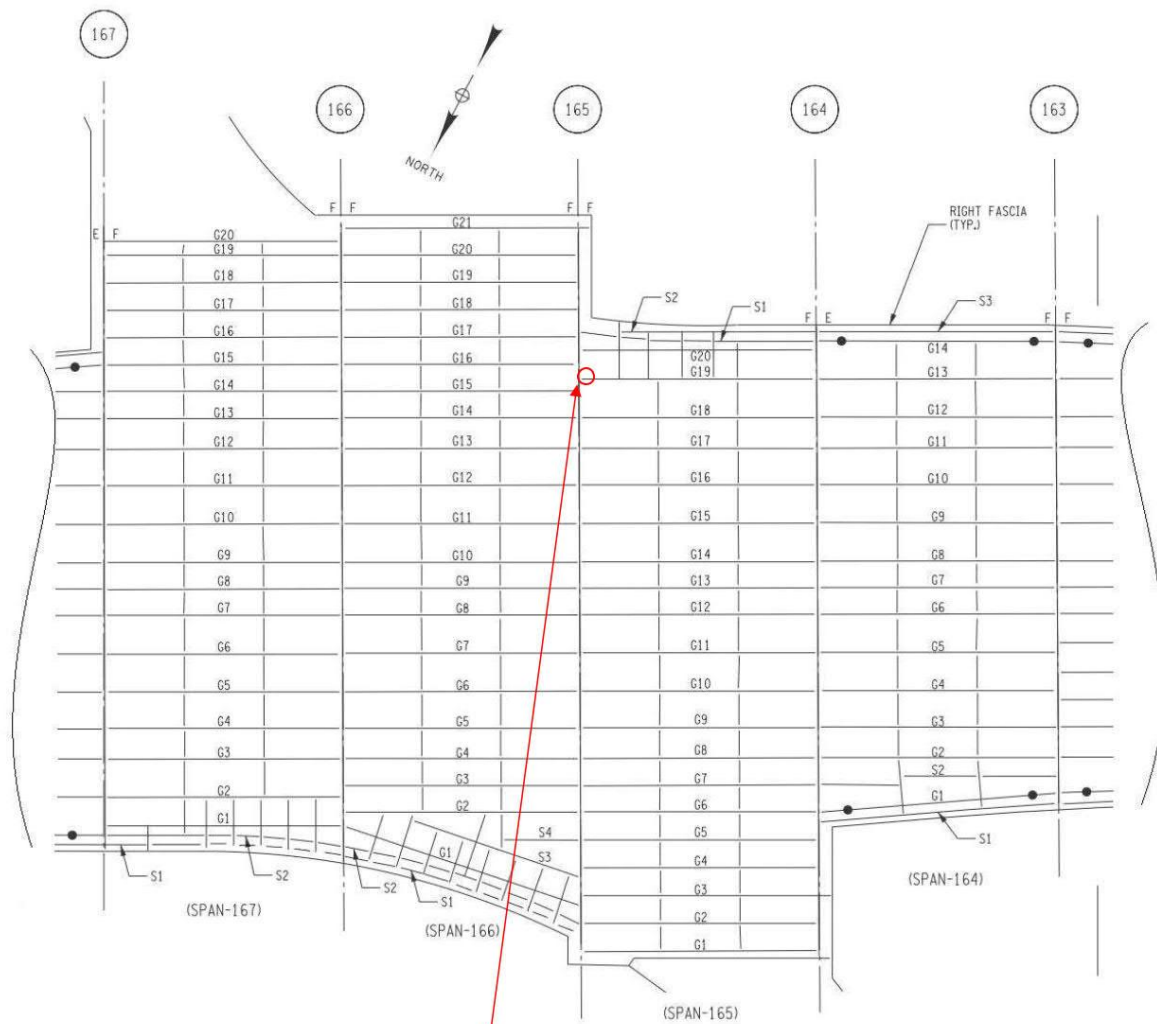
Photo Number: 5

**YELLOW FLAG LOCATION**  
**No. NB22CTW008**

**Attachment Description: SN 165 G19 at Pier 165 Framing Plan**
